**BUILDING 594 WASTE ION EXCHANGE FACILITY
FINAL SURVEY REPORT**

**ARGONNE NATIONAL LABORATORY
ARGONNE, ILLINOIS**

October 1998

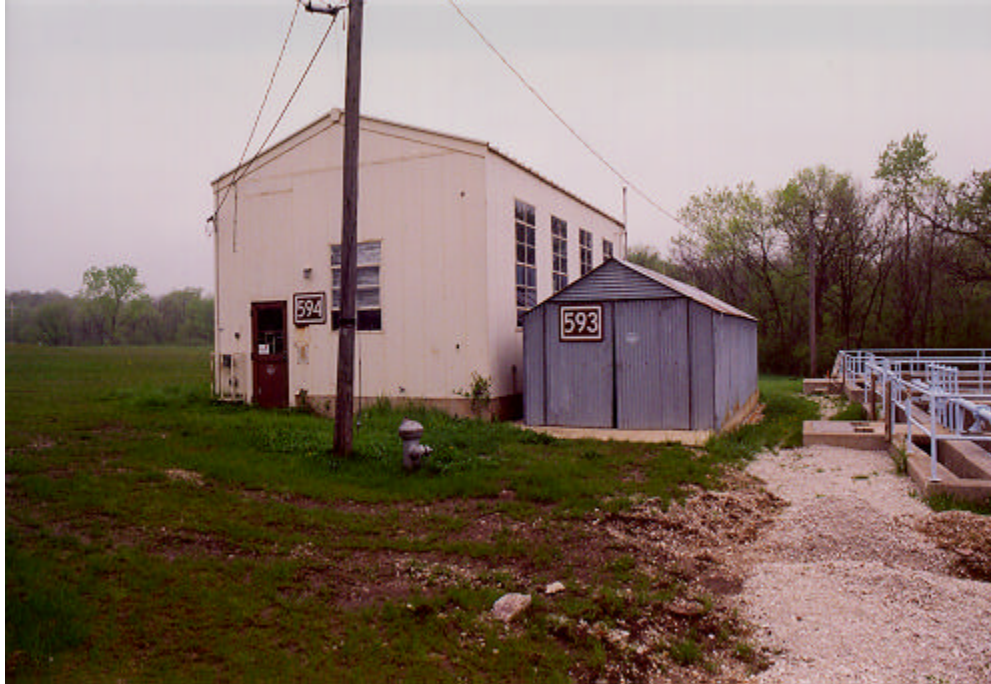
FIGURE 1 Waste Ion Exchange Facility, Building 594

The Waste Ion Exchange Facility building 594, (formerly 579) was a prefabricated, galvanized, metal building, 20 ft. wide by 32 ft. long by 14 ft. high (see Figure 1). It was constructed in the 1950's to enclose the waste ion exchange system that was used to process waste fluids from a collecting lagoon. The building contained ion exchange equipment that was connected to the collecting lagoon, equalization tanks, and Building 592 (formerly Bldg. 575) distribution pit by underground piping (see Figure 2). There were influent lines on the east side of the building and an effluent line on the north side of the building.

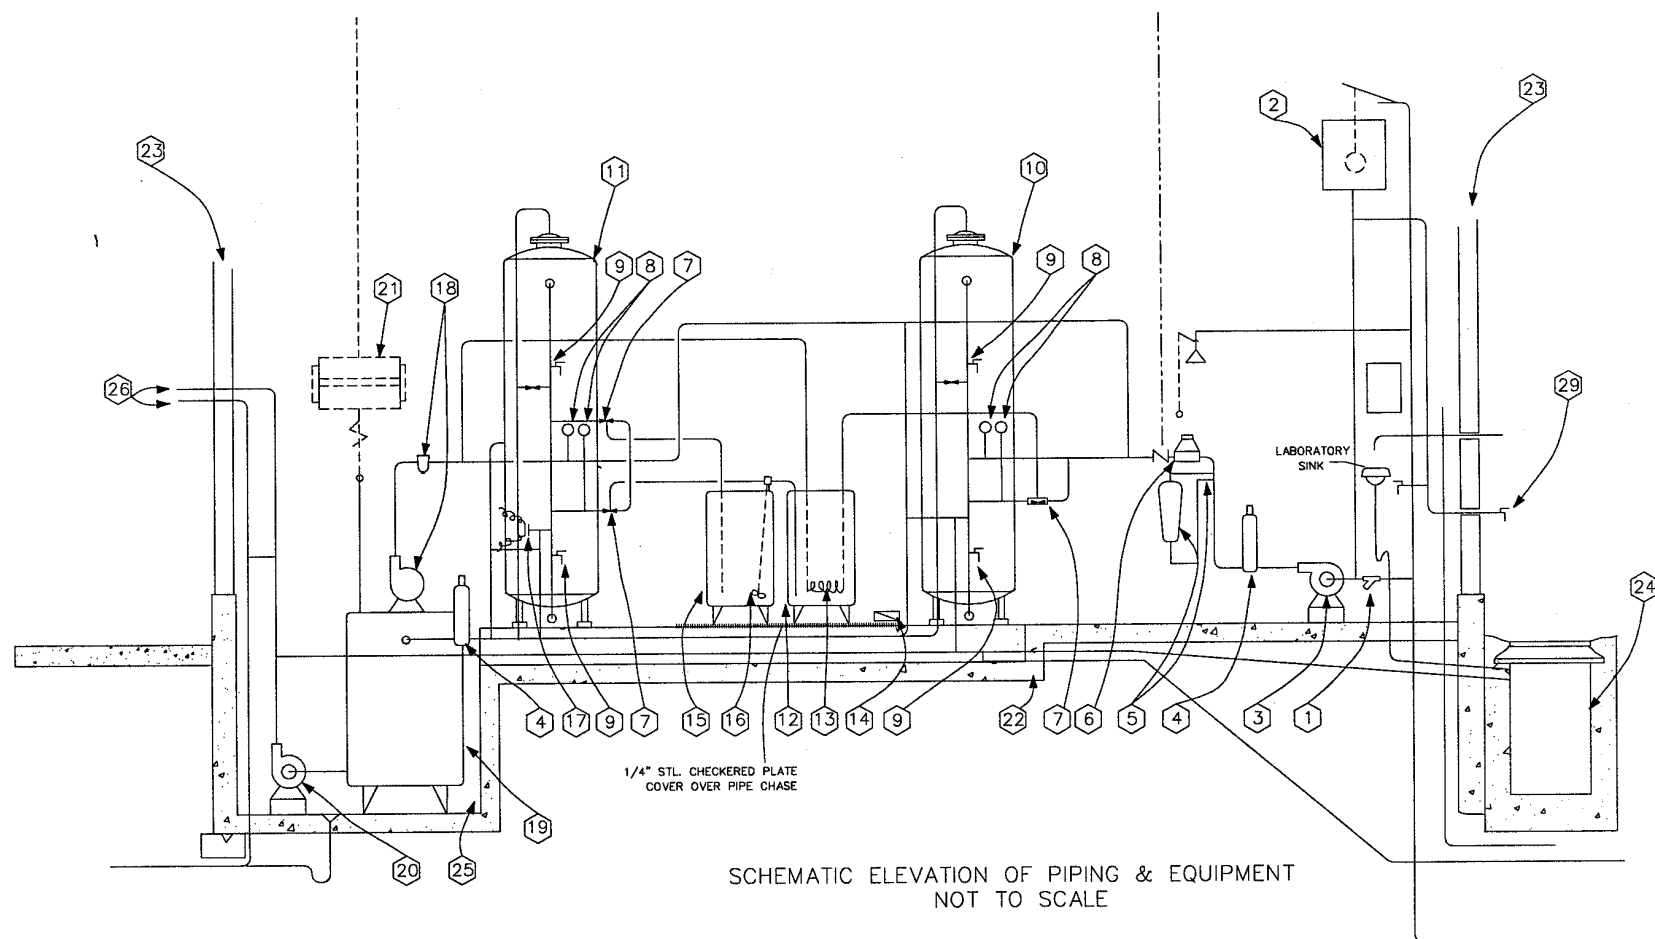
FIGURE 3 Building 594 Ion Exchange Piping & Equipment

The main components inside the Waste Ion Exchange Facility were the ion exchange vessels and associated piping located on the east side of the building (see Figure 3). The numbered components are identified in Table 1. Normal access to the facility was through doorways located on both the north and south ends of the building.

TABLE 1 Component Numbers and Names
(The component numbers and names show in
Figure 3.)

6. Catch Basin: The catch basin (#24 in Figure 3) was left in place. The piping from the basin is connected to a laboratory tank and equalization tank in building 592 (575 in Figure 2). A water sample from the catch basin was less than ten times the site release criteria. As found during the characterization, the catch basin had γ activity above the ambient background. The catch basin sample taken during the characterization appeared to contain only naturally occurring radionuclides. The activity levels are below the unrestricted release criteria. Therefore, the catch basin is released for unrestricted use.

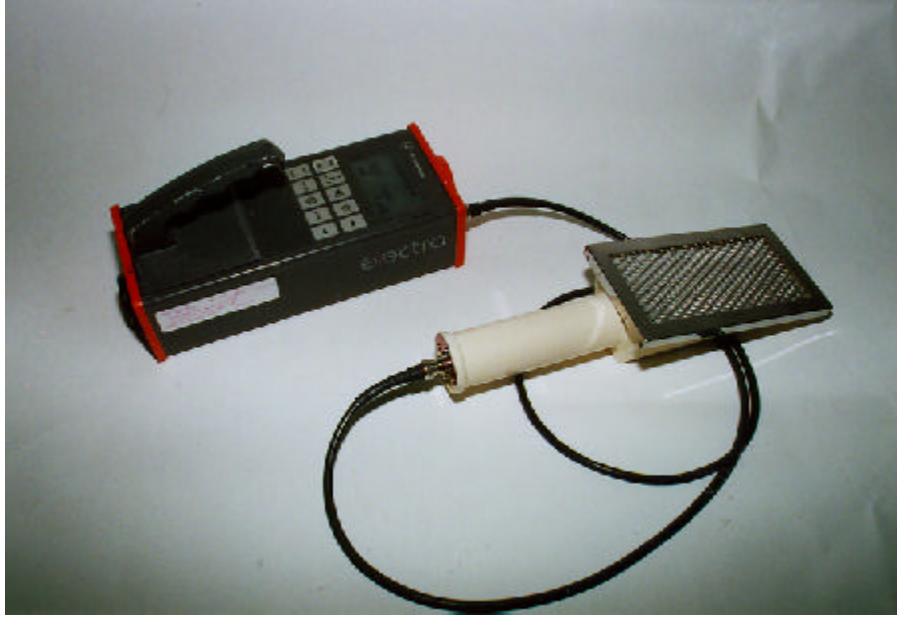
FIGURE 4 NE Technology Model Electra with 100 cm² Detector for Measuring $\alpha\beta\gamma$ Surface Contamination

Purpose	Instrument	Detector Description	Measurement Units	Typical Characteristics	Typical MDA ^a
Total Surface (α)	NE Technology, Ltd. ELECTRA	Dual Scintillator 100 cm ² sampling area 0.5 mg/cm ²	cpm	21% ²⁴¹ Am efficiency, 30 sec residence time, ≤7 cpm background	98 dpm
Total Surface (β - γ)	NE Technology, Ltd. ELECTRA	Dual Scintillator 100 cm ² sampling area ~ 6 mg/cm ²	cpm	29% ⁹⁰ Sr-Y efficiency, 30 sec residence time, ≤400 cpm background	410 dpm
Removable Surface (α)	Tennelec APC	Gas Proportional 5 cm dia. 0.1 mg/cm ²	cpm	30% ²⁴¹ Am efficiency, 2 min count time, ≤1 cpm background	17 dpm
Removable Surface (β - γ)	Tennelec APC	Gas Proportional 5 cm dia. 0.1 mg/cm ²	cpm	42% ⁹⁰ Sr-Y efficiency, 2 min count time, ≤40 cpm background	86 dpm
Removable Surface (α)	DABRAS	Gas Proportional 200 cm ² 0.4 mg/cm ²	cpm	27% ²⁴¹ Am efficiency, 2 min count time, ≤2 cpm background	18 dpm
Removable Surface (β - γ)	DABRAS	Gas Proportional 200 cm ² 0.4 mg/cm ²	cpm	49% ⁹⁰ Sr-Y efficiency, 2 min count time, ≤270 cpm background	86 dpm

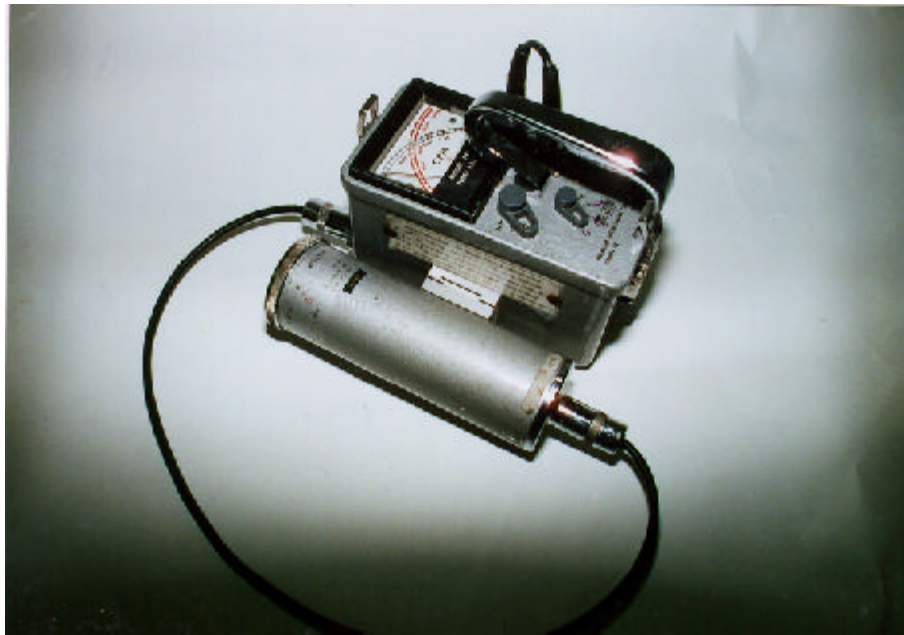
**FIGURE 7 Eberline PRM-5-3 with PG-2 Scintillation Detector
(2" × 2 mm thick NaI detector)**

Find Elevated x- γ	Eberline PRM 5-3 with PG-2 detector	5 cm diameter x 2 mm thick NaI (TI)	cpm	2 sec residence time 500 cpm background	1500 cpm net

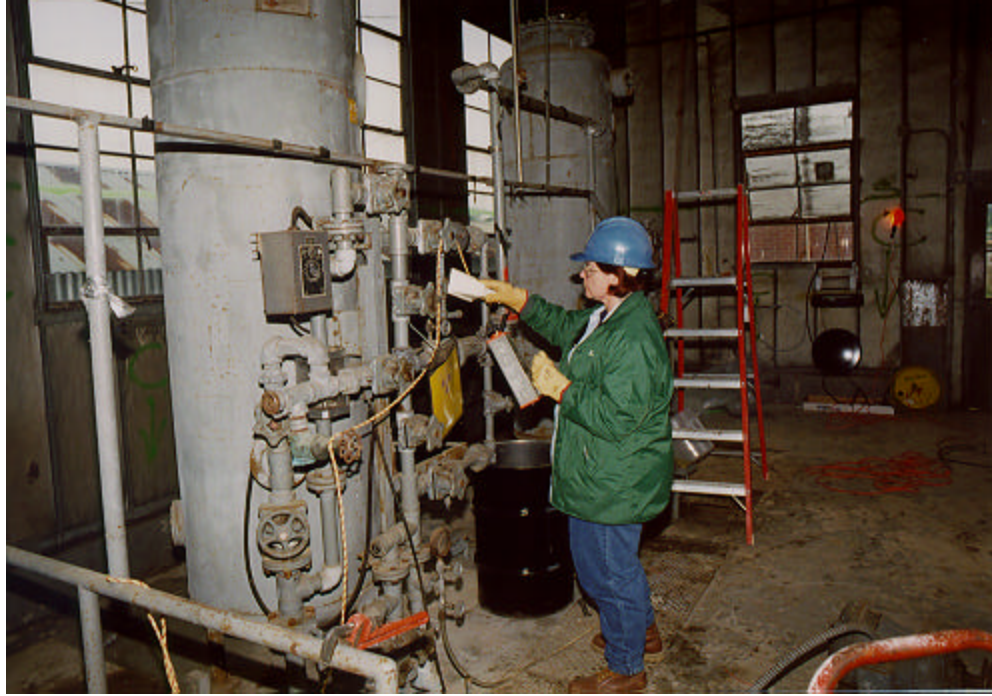
FIGURE 8 Health Physics Survey of the Cation Exchange Vessel, Mixed Bed Exchange Vessel and Equipment

3. The Cation Exchange Vessel and the Mixed Bed Exchange Vessel (See Figure 8) were then removed, placed on their sides and vacuumed by WMO. The tanks were surveyed, size reduced, and disposed of as clean scrap metal.

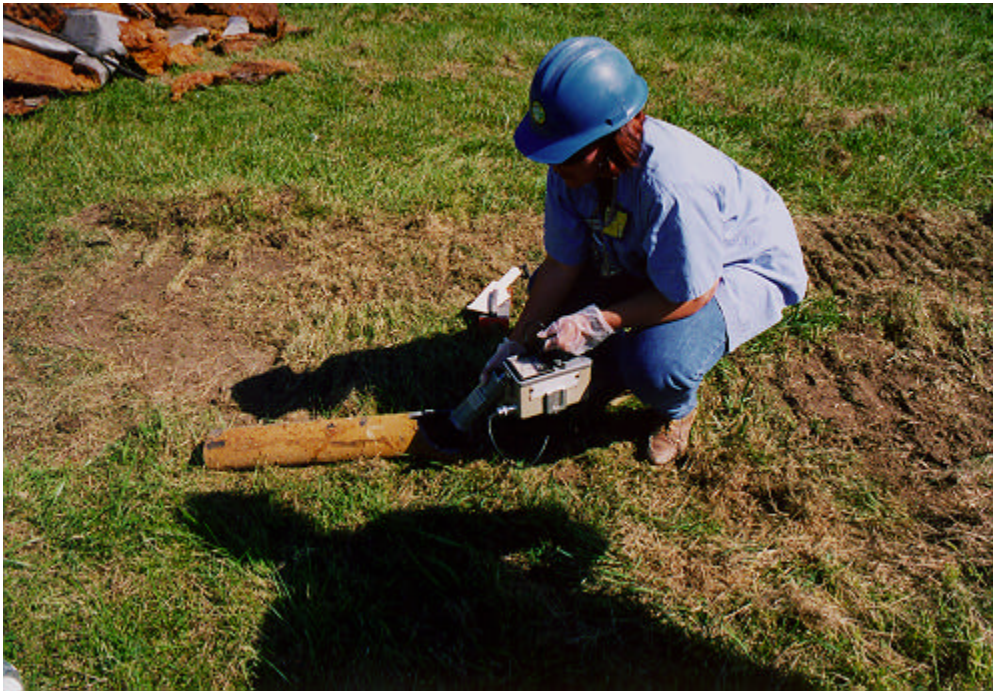
FIGURE 9 Health Physics Survey of Piping from beneath Building 594 Concrete Pad

9. Building 594 and associated piping and concrete were demolished and removed as scrap in September, 1998. On September 11, 1998, ESH Health

Physics personnel surveyed the piping that was inaccessible under the concrete (See Figure 9). Pipes involved were those pipes that ran from under the concrete to the north pit drain and east pit drain leading to the water treatment settling basin. No contamination was detected. The north drain line was removed to three feet outside of the foundation of the building. The east drain line was removed to the foundation of building 593 (see Figure 1).
